Greenburgh Central School District

Structural Assessment, Administrative Building

■ March 25, 2020
Update

Greenburgh Central School District Administration Building Structural Assessment Report

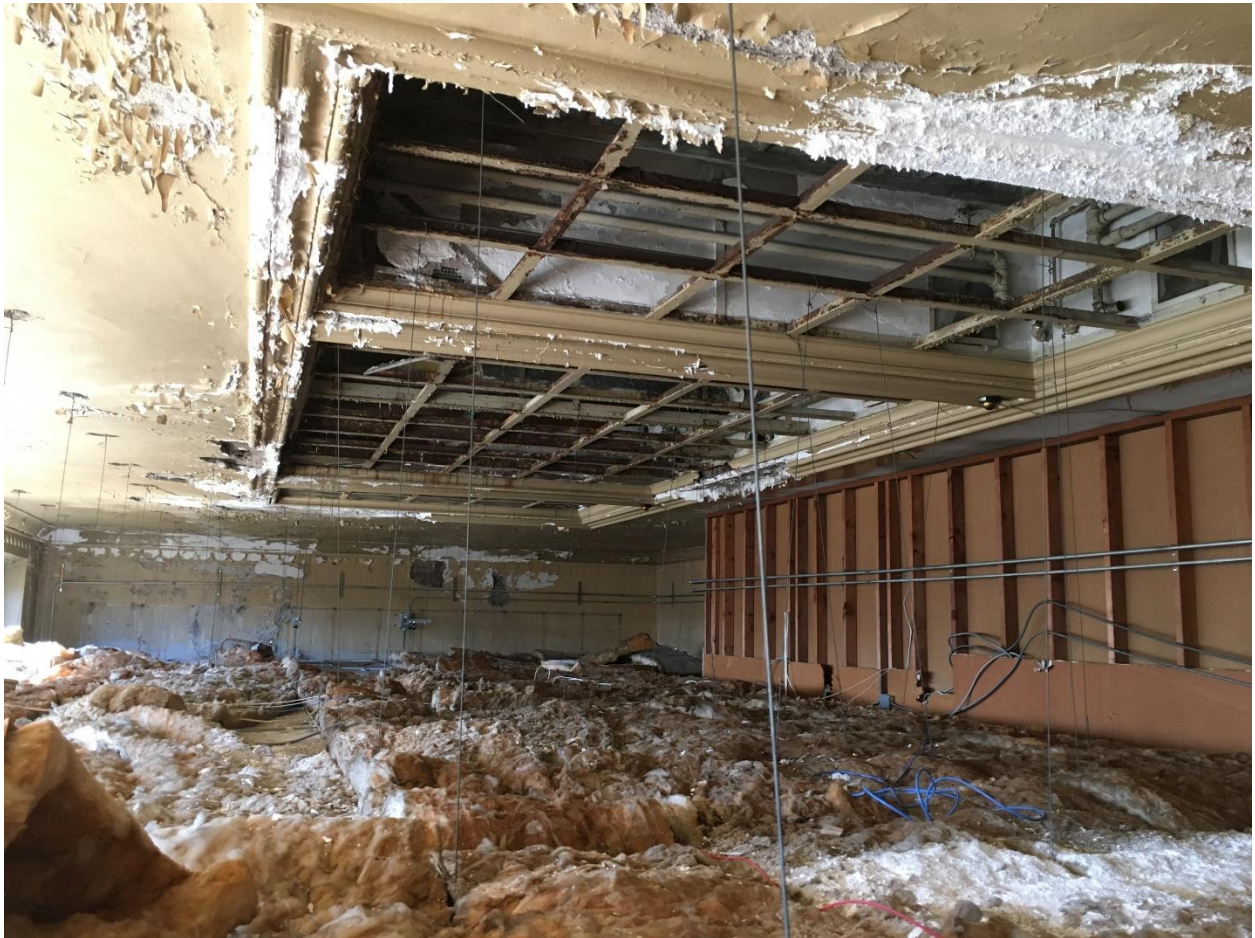
Above the ceiling in ECP rooms 2 & 3

4. At the Early Childhood Program Rooms 2&3, (former pool area), we have the plaster ceiling deterioration. This ceiling is original to this section of the building and lies 6-7' above a suspended ceiling that was installed when the space was renovated to classrooms. The plaster is in varying stages of deterioration seemingly due to water penetration over time, possible roof leaks and possible migration of water through masonry elements. It appears as though several areas have dropped onto the ceiling below. In the CS Arch September 16th memo, this area is no longer indicated as one of the four areas of safety concern, however, the structural report of September 13th still recommends the removal of this ceiling. We agree this remains a safety concern should plaster release and fall through the suspended ceiling below during building occupancy.

exiting requirements and should be noted as a non-conforming item on your Evaluation of Existing Buildings when submitting a project to SED for review. **This condition needs to be corrected!** Also, when viewing above the ceiling in the ECP rooms 2&3, it could be seen that the corridor wall only has single sided sheetrock above the ceiling level and there is no wall between the classrooms above the ceiling level. The corridor wall does not provide a proper fire separation for exiting purpose whereas the lack of a wall between the rooms is more of an acoustical issue.

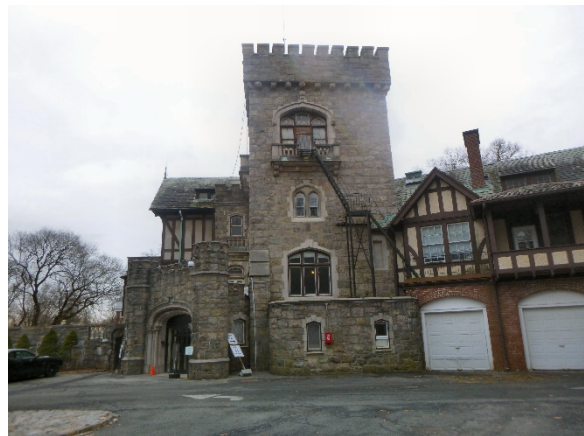
Photo No. 2
Location: Tower turret
Description: General view.

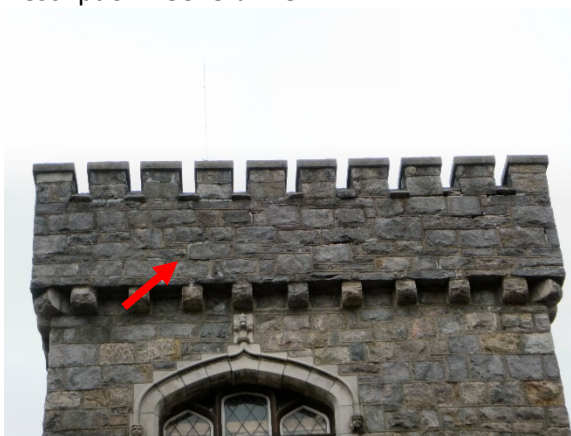
- 1.1. The granite between the turret openings is deteriorated and splitting along the exterior face (Ref. photo nos. 2 and 3).
- 1.2. Pointing is deteriorated and missing between the granite joints at the turret.
- 1.3. Along the cantilever porch over the garage door, joist ends have wood rot (Ref. photo nos. 4 and 5).

Photo No. 3
Location: Top of tower turret.
Description: Deteriorated and splitting granite.

- 2.1. Exterior masonry repairs. These will include brick/stone stitching, replacement of cracked stones and mortar joint pointing.
- 2.2. Replacement/reinforcement of affected wood framing elements of the 1st floor in Area C displaying insect damage.
- 2.3. Reconstruction of partition walls and their finish in 2nd floor rooms of area C.
- 2.4. Further investigation of the deflection in the floor of room 3023.
- 2.5. Reconstruction of failed site retaining walls.

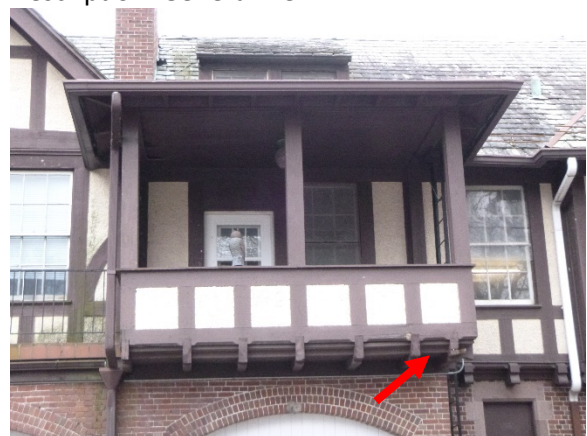
Photo No. 4
Location: Porch above sectional doors.
Description: Wood decayed at ends of joists.

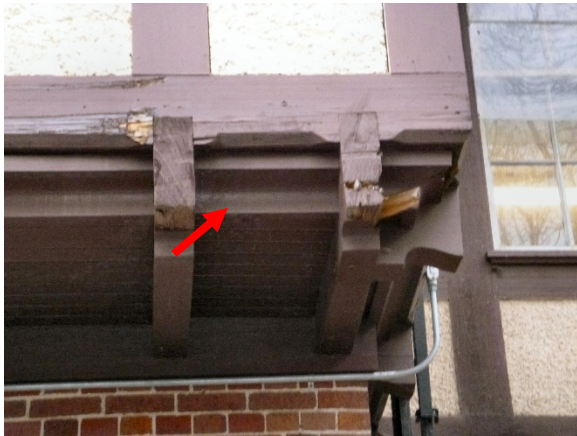
Photo No. 5

Location: Close-up of photo no.4.

Description: Wood rot at ends of joists.

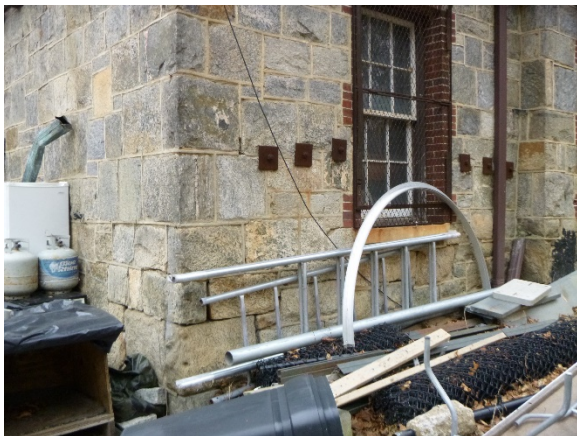
Photo No. 6

2.1. Open and missing joints at the stone foundation wall at basement level (Ref. photo no. 6).

Location: Basement foundation stone wall.

Description: Open and missing joints.

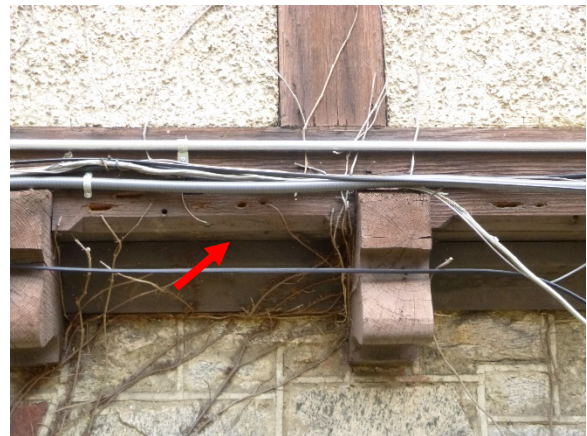
Photo No. 7

2.2. Insect damage to wood/rot at wood members randomly throughout at first floor (Ref. photo nos. 7 to 10).

Location: First floor exterior wood members.

Description: Insect damage.

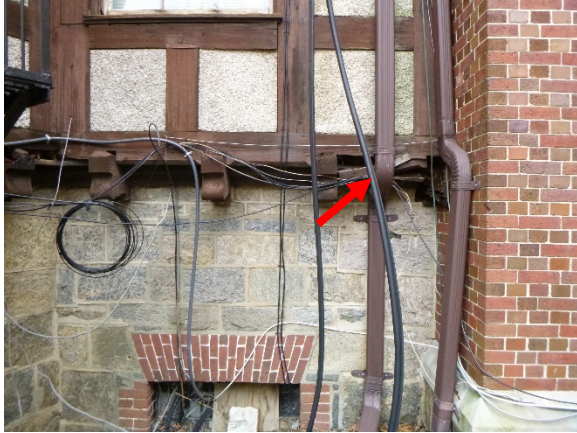
Photo No. 8
Location: 1st floor wood trim.
Description: Wood rot and insect damage.

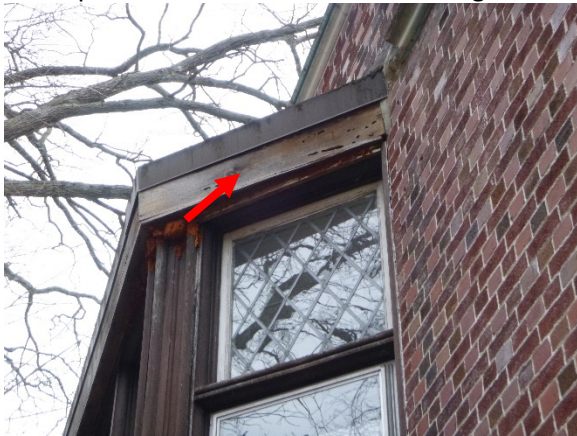
Photo No. 10
Location: Bay window at 1st floor.
Description: Insect damage.

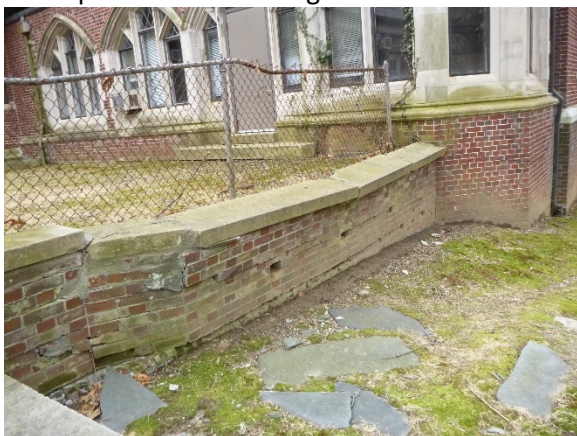
2.3. Retaining wall and property wall at two locations has tilted out at one location and has failed at another location (Ref. photo nos. 12 & 13).

Photo No. 12
Location: Solid brick retaining wall.
Description: Wall tilted out.

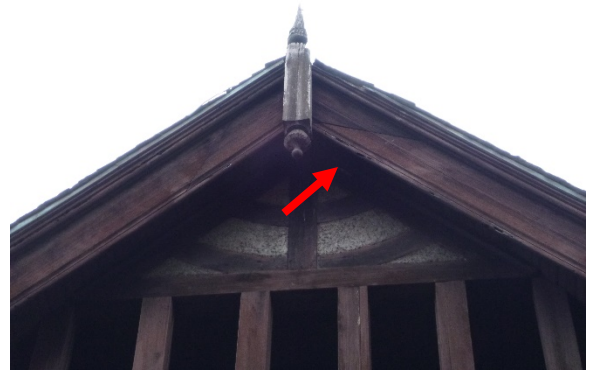
Photo No. 9
Location: Open porch at 2nd floor.
Description: Insect damage at rafter.

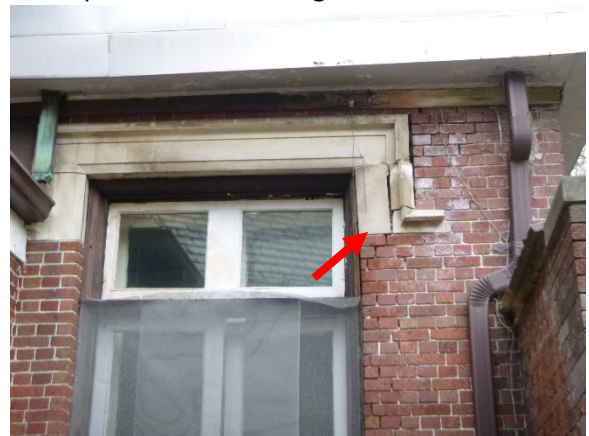
Photo No. 11
Location: Cast stone lintel at window.
Description: Open and missing joint material.

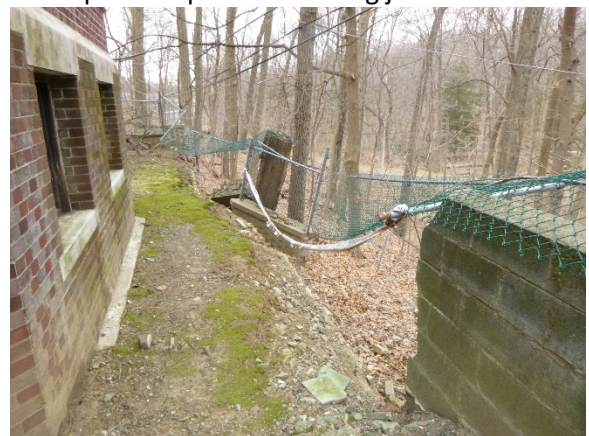
Photo No. 13
Location: Property wall.
Description: Brick wall failed.

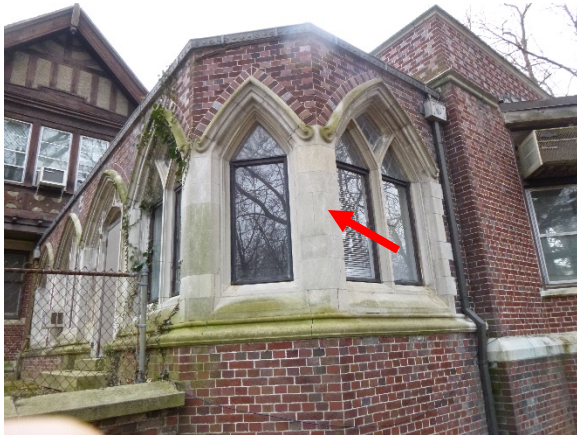
2.4. At cast stone of window openings there are several random cracks (Ref. photo nos. 14 & 15).

Photo No. 14
Location: West elevation
Description: Cast stone cracked at window openings.

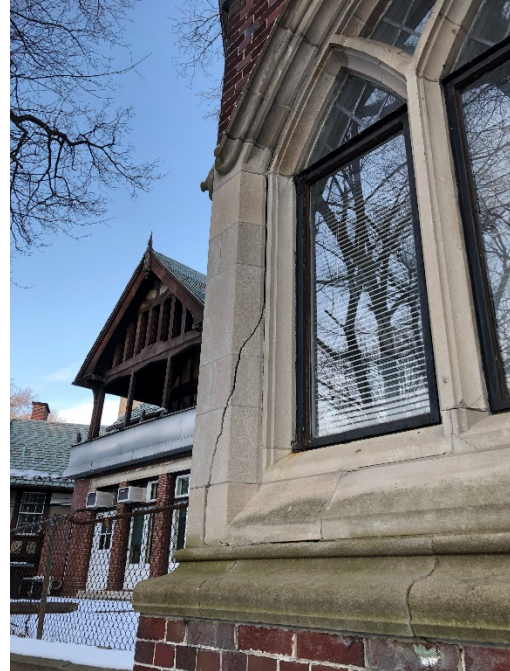
Photo No. 15
Location: Close-up of photo No. 14.
Description: Cracked cast stone.

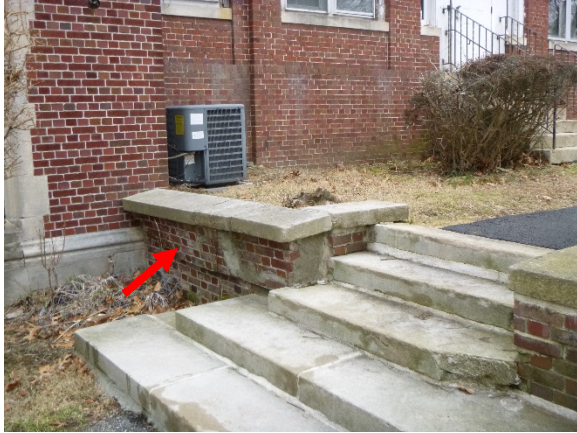
- 3.1. There is a solid brick masonry wall hat has partially failed adjacent to the stairs (Ref. photo no. 16).
- 3.2. Deteriorated pointing was observed at Early Childhood Program Room 1 (Ref. photo no. 17).
- 3.3. At two corners along south elevation the parapet has cracked at two locations (Ref. photo nos. 18 & 19)
- 3.4. Stairs to Early Childhood Program Room 1 spalled and missing exterior brick work at sides (Ref. photo no. 20).

Photo No. 16
Location: Retaining wall adj. stairs.
Description: Partially failed retaining wall.

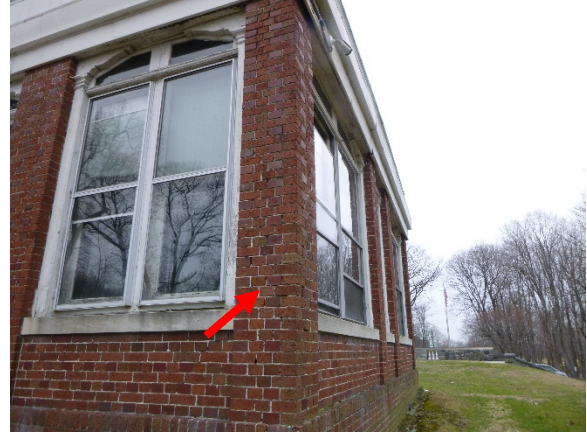
Photo No. 17
Location: ECPRM1
Description: Localized deteriorated pointing.

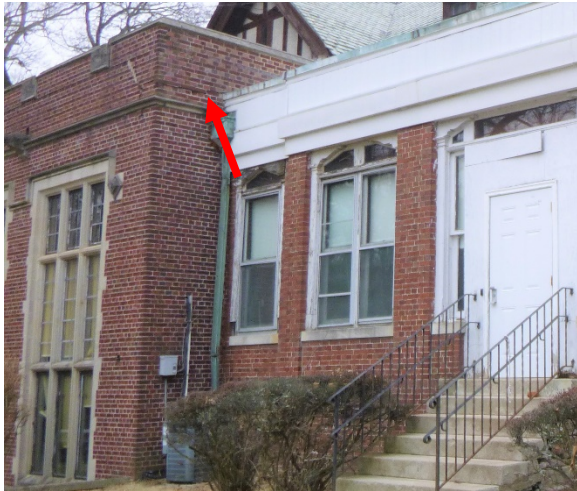
Photo No. 18
Location: Parapet at corner cracked.
Description: Parapet cracked.

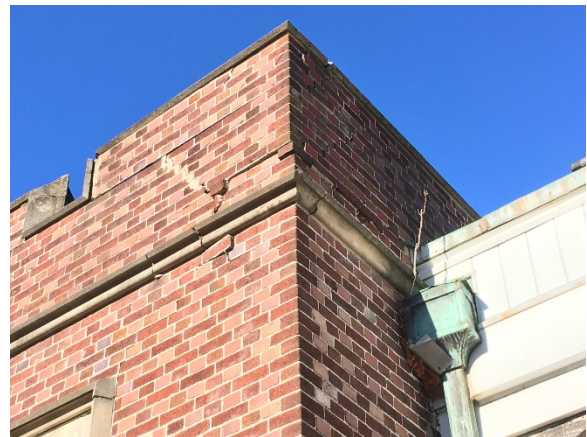
Photo No. 19
Location: Close-up of photo no. 18.
Description: Parapet cracked.

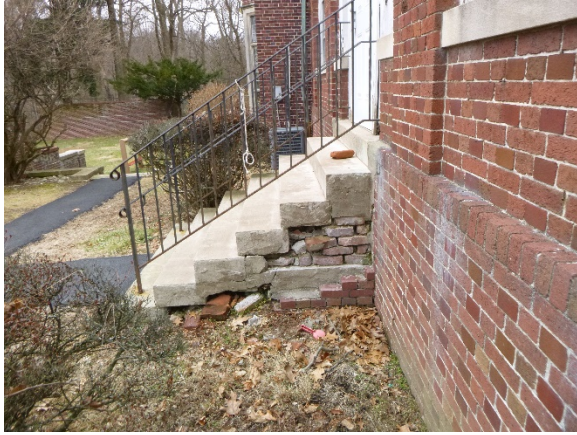
Photo No. 20

Location: Stair at south elevation.

Description: Spalled and missing bricks at both sides.

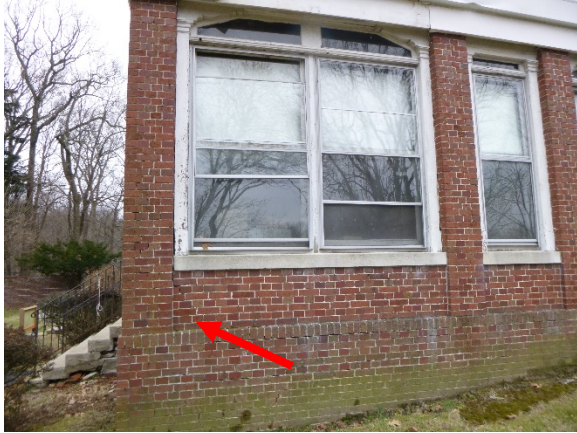
- 4.1. At the Early Childhood Program Room 1 (ECPRM1) there were several settlement cracks at the exterior masonry wall above grade (Ref. photo nos. 21 to 23)
- 4.2 At the first floor the brick masonry wall exhibits several step cracks from settlement that has been repaired with a sealant (Ref. Photo No. 24)
- 4.3. Open horizontal joints were observed due to settlement of the wall at area near enclosed porch (Ref. photo no. 25)
- 4.4. At the 3rd floor horizontal wood beam below hip roof has open seam with wood rot (Ref. photo no. 26)
- 4.5. At the first-floor brick masonry wall adjacent to the north elevation below the lower roof setback there is a vertical separation crack at wall (Ref. photo no. 27).
- 4.6. At the tower turret at the upper portion there are deteriorated and open joints at the granite (Ref. photo no. 28).

Photo No. 21
Location: ECPRM1
Description: Vertical open settlement crack.

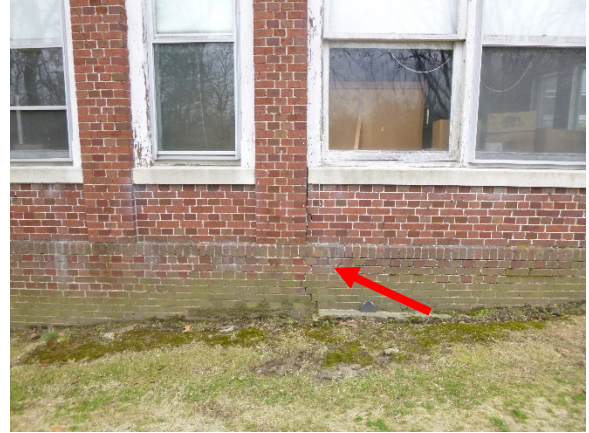
Photo No. 22
Location: ECPRM1.
Description: Vertical open settlement crack.

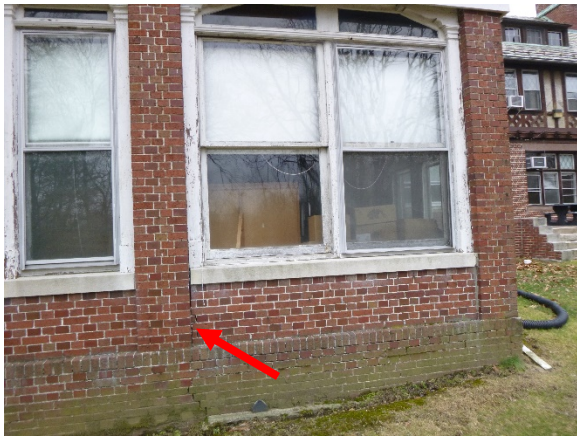
Photo No. 23
Location: ECPRM1
Description: Vertical open settlement crack.

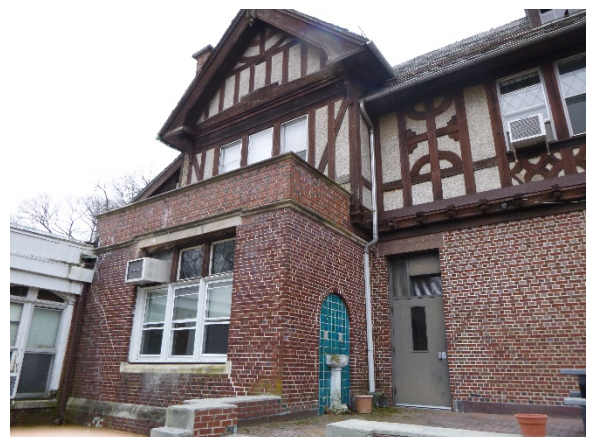
Photo No. 24
Location: Exterior brick masonry wall.
Description: Step cracks repaired with sealant.

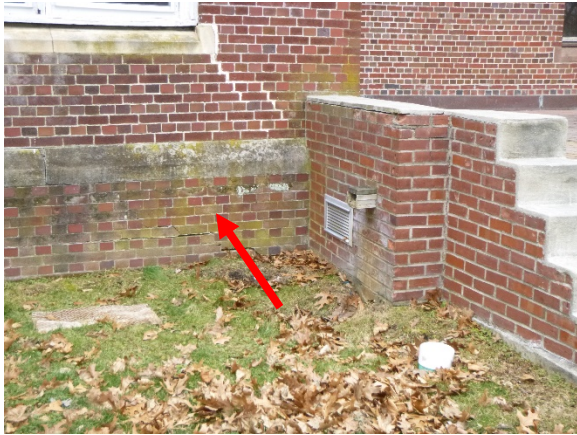
Photo No. 25
Location: Brick masonry wall.
Description: Open horizontal joint.

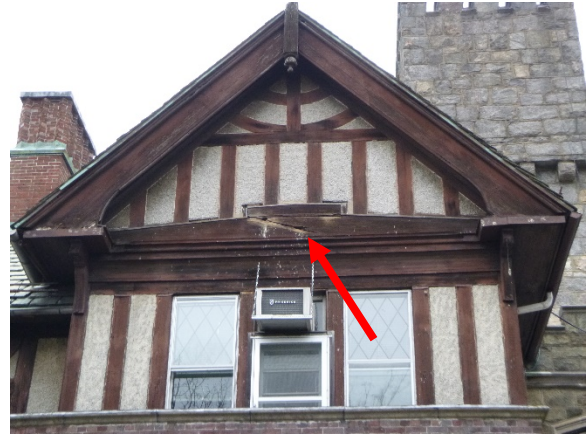
Photo No. 26
Location: Horizontal wood member.
Description: Wood rot and open seam.

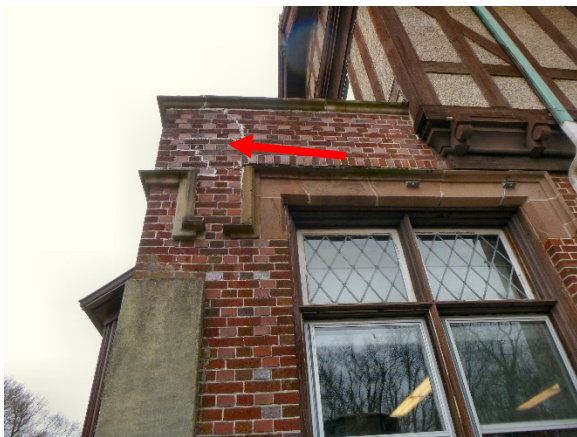
Photo No. 27
Location: 1st floor below roof setback.
Description: Separation crack at parapet

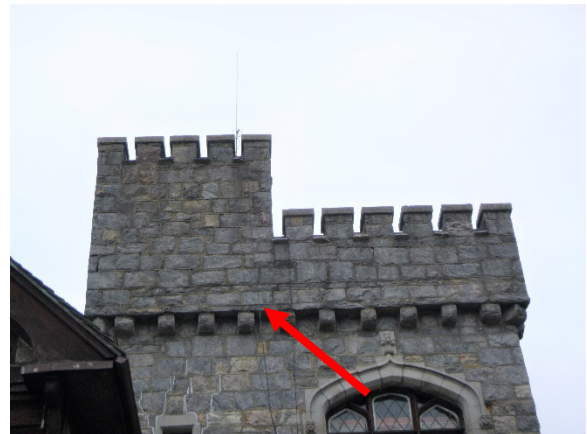
Photo No. 28
Location: Tower turret.
Description: Deteriorated and open joints.

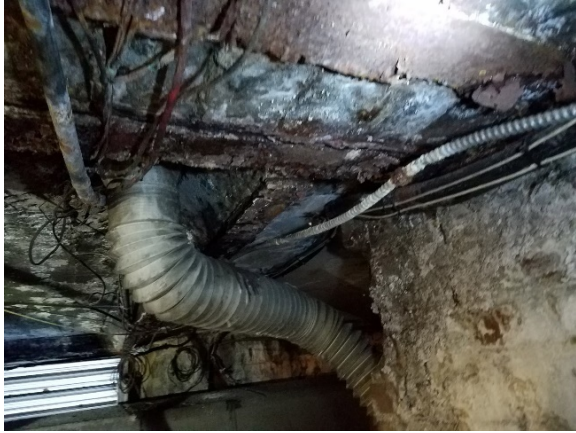
Photo No. 1 Deteriorated steel framing

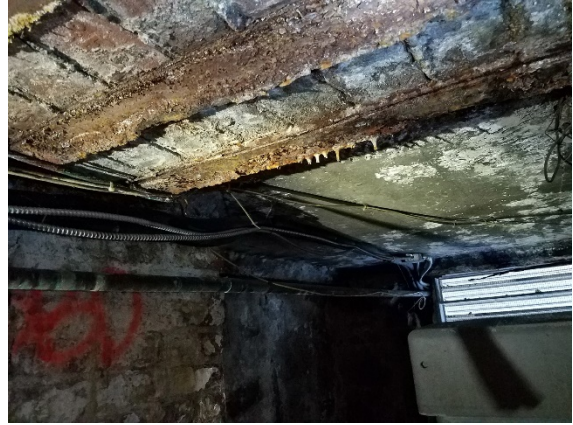
Photo No. 2 Deteriorated steel framing

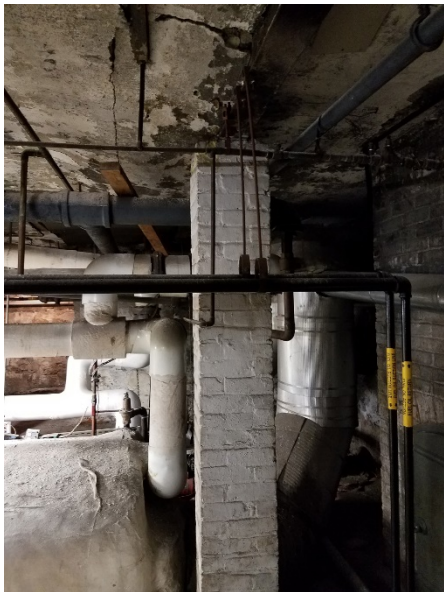
- 1.1. Overall condition of basement masonry walls, both exterior and interior is satisfactory. No major deficiencies were observed.
- 1.2. Basement ceiling/1st floor framing – deteriorated plaster ceiling was observed in boiler room. **Hazardous condition as ceiling can be asbestos contaminated.** (location 2, Photo #3)

Photo No. 3 Damaged plaster ceiling
in boiler room

- 1.1. Ceiling in the boiler room should be removed and replaced with new ceiling complying with required fire rating. (Item III.1.1 of observations)
- 1.2. Deteriorated beams in the boiler room areas should be replaced and concrete slab repaired. Walkway above should be temporarily closed from public access. (Item III.1.3 of observations)
- 1.3. Deteriorated floor in rooms 2023 shall be repaired. (Item III.2.1 of observations)
- 1.4. Deteriorated original ceiling over the old pool shall be removed. (Item III.2.2 of observations)
- 1.5. Framing of the porch roof shall be reconstructed. (Item III.5.2. of observations)

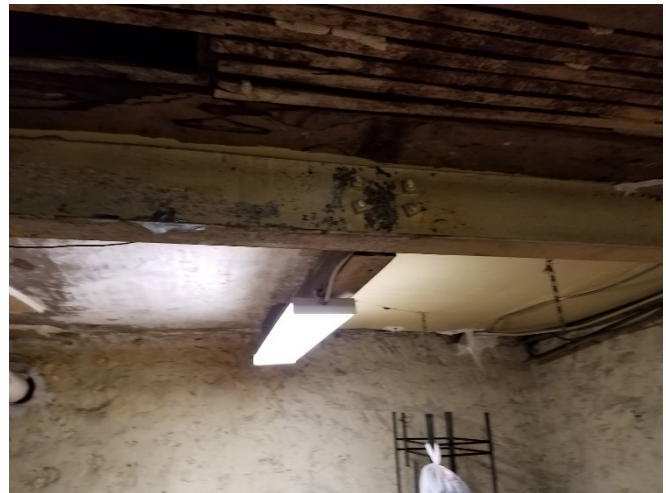
- 1.3. Heavily corroded steel beams were observed at basement rooms adjoining the boiler room. These include lintels over masonry openings and roof framing beams. **Hazardous condition as loss of steel cross-section estimated at 60%.** (location 1, Photo #1 and #2)
In other areas of the basement where exposed steel framing could be inspected the condition of the steel members is satisfactory – see Photo # 4.

Photo No.4 Steel beams of the 1st floor framing
in satisfactory condition.

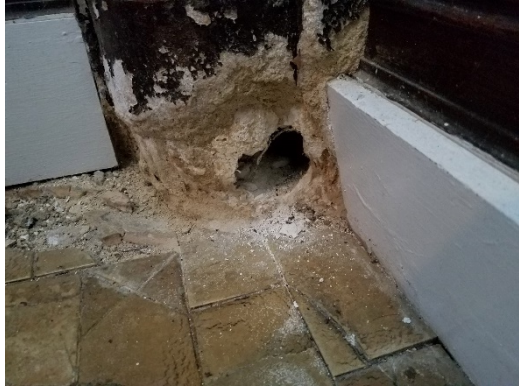
- 1.5. Deteriorated/corroded decorative column was observed at main entrance. As the column is not a structural element there is no impact on overall stability of the structure. (location 3, Photo #5).

Photo No. 5 Deteriorated decorative column.

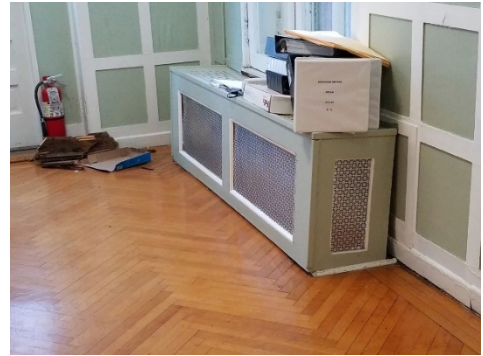
- 2.1. Severe floor settlement was observed in room 2023 (location 1) and moderate settlement in room 2036 (location 2). Probe was previously opened in room 2023 – 3x10 wood joist was observed to be in satisfactory condition. In both of these locations exterior walls are not supported by basement walls and have independent foundations but only minor settlement was observed in the walls. Settlement of the soil backfill under the floor support may contribute to the observed floor damage. **The deterioration constitutes hazardous condition.** (Photo #6 and #7)

Photo No. 6 Settled floor
In room 2023.

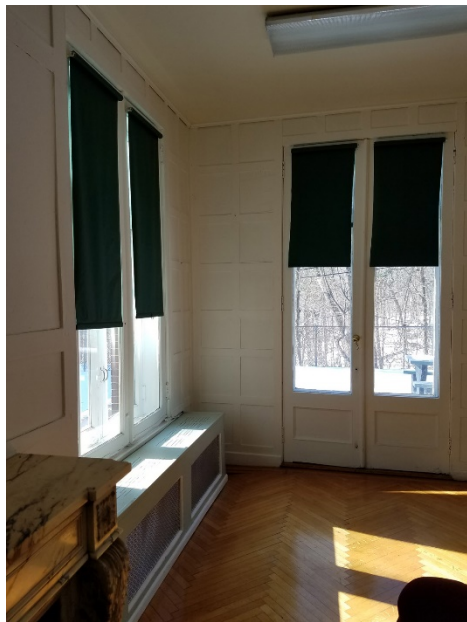
Photo No. 7 Settled floor in room 2023

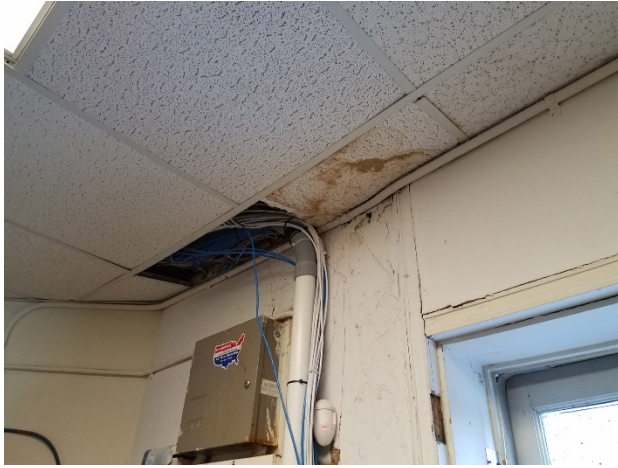
- 2.2. In area of the original pool a new suspended ceiling was installed in the past some 3'-4' below the original plaster ceiling. Continuing water infiltration caused suspension structure of the new ceiling to corrode. Heavy efflorescence is present both on the original ceiling and on the surrounding walls above the suspended ceiling. Lack of proper ventilation in the area above suspended ceiling may contribute to ongoing deterioration. **Condition of the original ceiling in over old pool constitutes hazardous condition.** (location 7, Photo #10)
- 2.3. Water leak is evident in small room near main staircase (location 3, Photo #8)
- 2.4. Cracking of plaster finish was observed in room 2035.

Photo No. 8 Leak in room 2002.

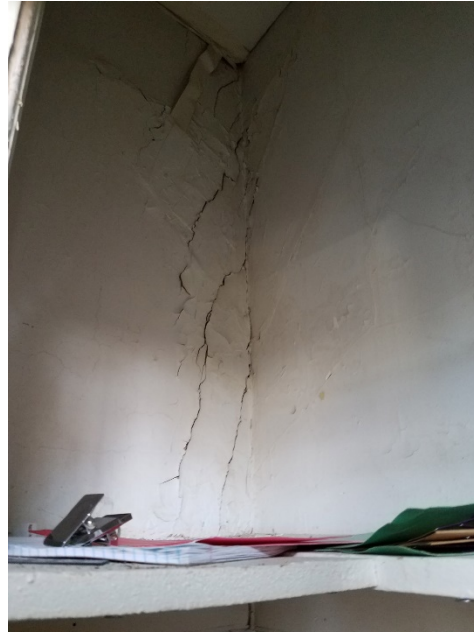
- 3.1. Insect damage to exterior wood members of the 1st floor, described in item II. 2.2. of exterior observations is causing excessive movement in the framing of the 1st floor of Area C.
- 3.2. Severe cracking of plaster finish was observed in several locations, both in exterior walls and interior partitions. We consider this to be a symptom of movement/deflections in wood framing of the structure. (Photo #9)

Photo No. 9 Cracked plaster in room 2022

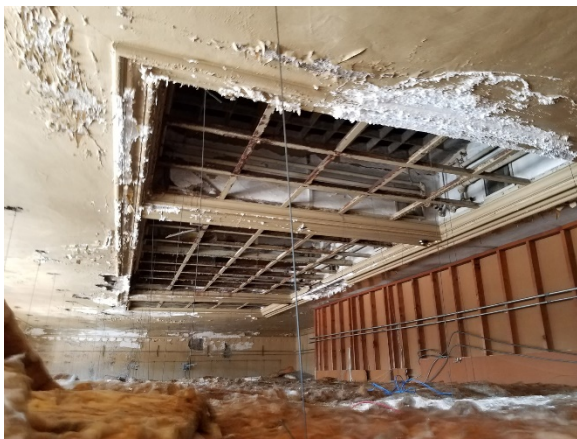
Photo No. 10 Deteriorated plaster and efflorescence in the ceiling above old pool.

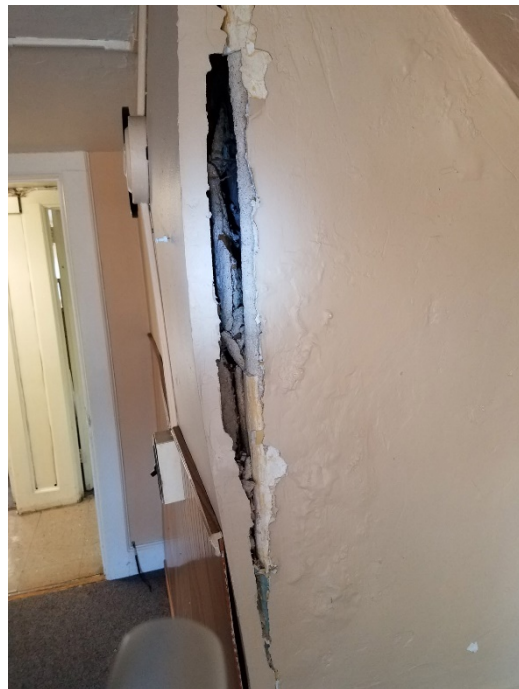
11. In room 3013, there was a large section of wall plaster and lath that has released from the wall framing. This and several other areas of plaster damage throughout this section of the building should be removed and repaired.

- 5.1. Severe cracking of plaster finish was observed in several locations in interior partitions. We consider this to be a symptom of movement/deflections in wood framing of the structure. Location 6. (Photo #11)

Photo No. 11 Cracked plaster in room 3013

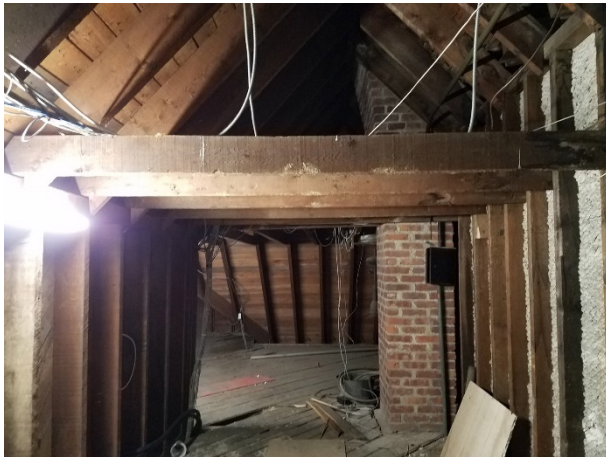
- 4.3. Water leaks were observed in several locations – locations 3, 4 and 7.
- 4.4. Wood framing of the gable roof over Area A is exposed in the attic space allowing close-up inspection. In general, wood members are in satisfactory condition. (Photo #12).

Photo No. 12 Main roof framing.

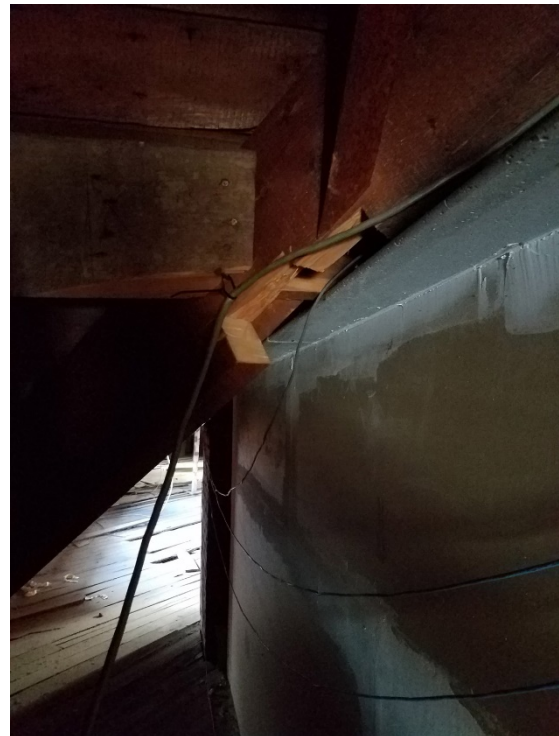
- 4.5. One of the valley rafters of the framing was cut/trimmed to accommodate new partition in the attic space. **Hazardous condition - affected rafter has to be reinforced to restore its original structural capacity.** (Photo #13).

Photo No. 13 Cut out in 12X3 valley rafter.

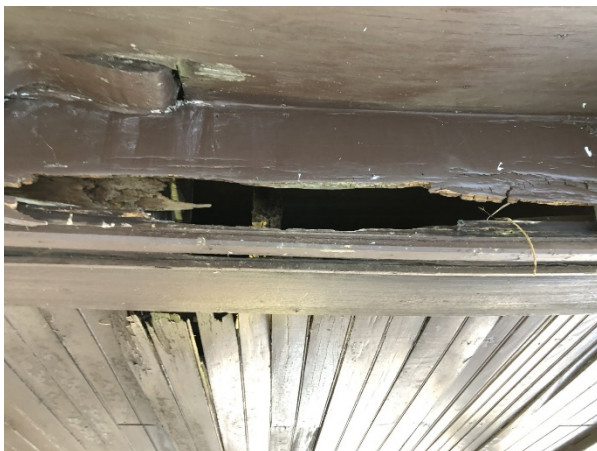
- 5.2. Framing of the roof over cantilevering porch at south elevation of area C is compromised. Wood joists are heavily deteriorated, in particular at location 5A – suspected cause is combined water and insect damage. **Hazardous condition and the roof framing over the porch has to be reconstructed – area 5 and 5A, Photo # 14.**

Photo No. 14. Deteriorated framing and ceiling over porch

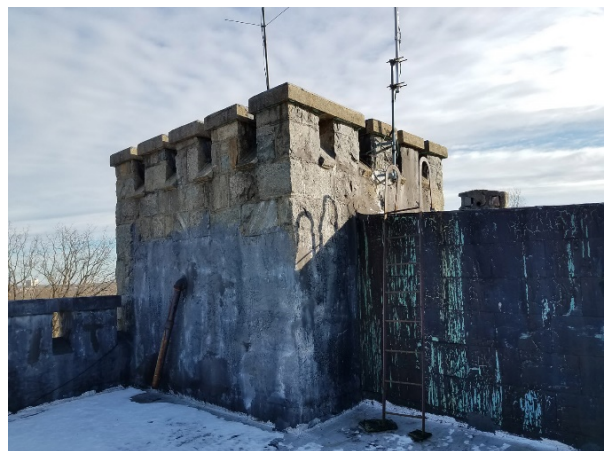
Photo No. 15. Tower roof
