Greenburgh Central School District

Structural Assessment, Administrative Building

■ March 25, 2020
Update

Greenburgh Central School District Administration Building Structural Assessment Report

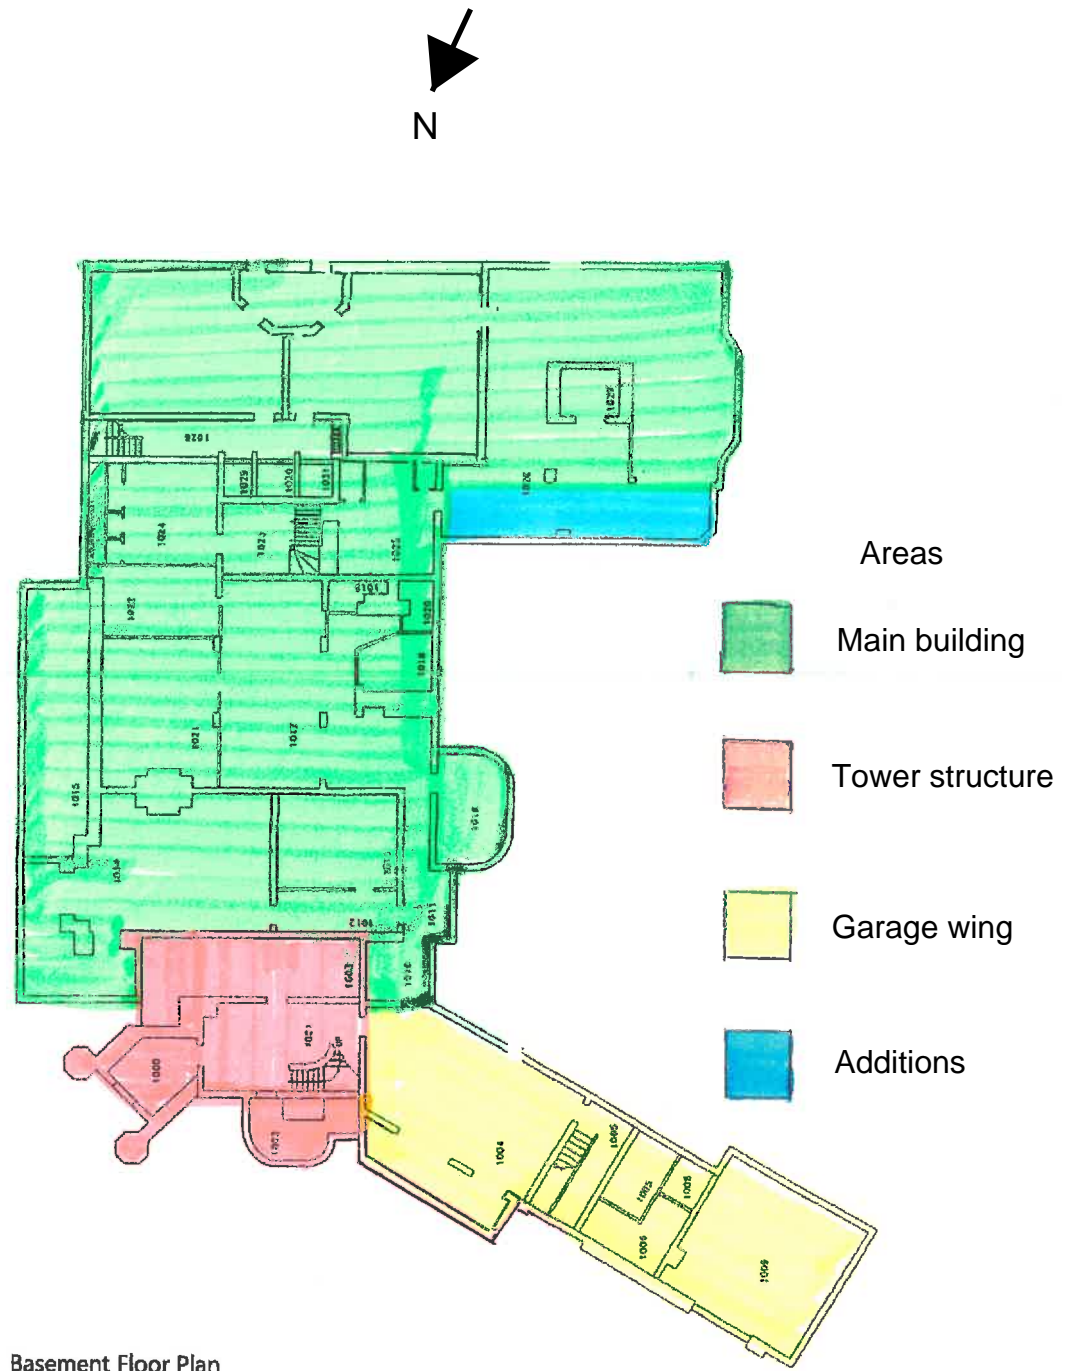
Figure 1

For the purpose of describing structural components of the building it is helpful to divide the footprint of the structure into 4 areas as show in figures 1 to 3.

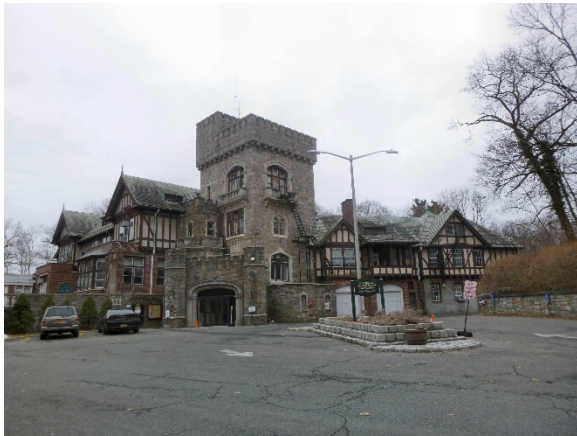
Photo No. 1
Location: North elevation
Description: General view.

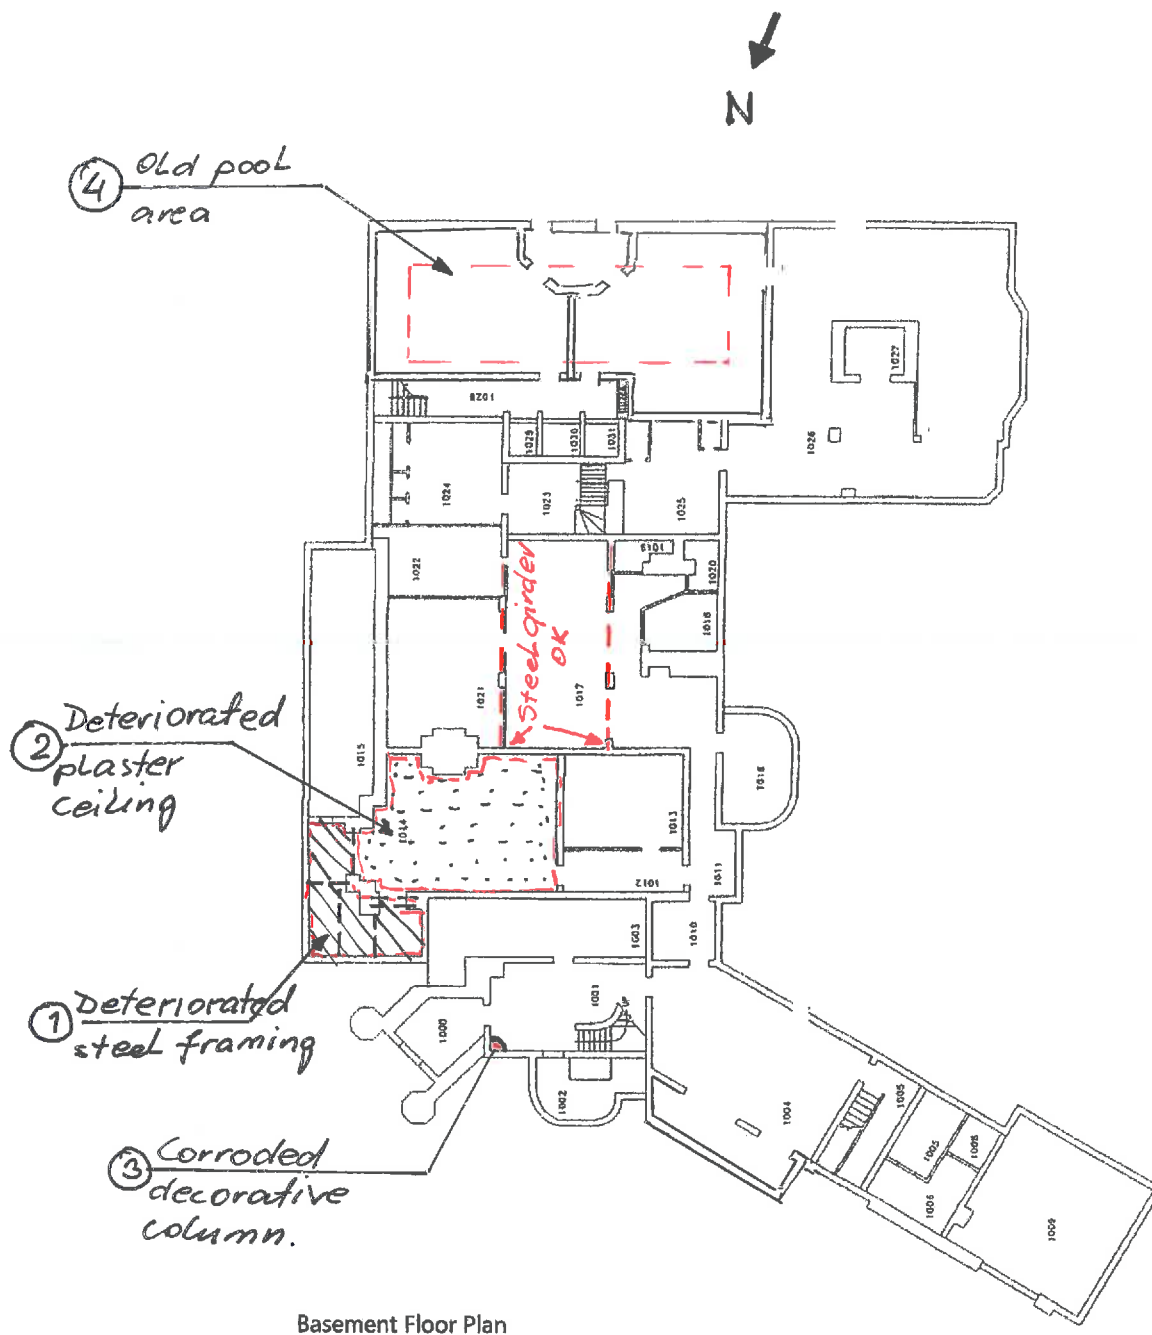
1. Basement – areas A, B and C - see plan Figure 4 for locations.

- 1.1. Overall condition of basement masonry walls, both exterior and interior is satisfactory. No major deficiencies were observed.
- 1.2. Basement ceiling/1st floor framing – deteriorated plaster ceiling was observed in boiler room. **Hazardous condition as ceiling can be asbestos contaminated.** (location 2, Photo #3)

- 1.3. Heavily corroded steel beams were observed at basement rooms adjoining the boiler room. These include lintels over masonry openings and roof framing beams. **Hazardous condition as loss of steel cross-section estimated at 60%.** (location 1, Photo #1 and #2)
In other areas of the basement where exposed steel framing could be inspected the condition of the steel members is satisfactory – see Photo # 4.

- 1.5. Deteriorated/corroded decorative column was observed at main entrance. As the column is not a structural element there is no impact on overall stability of the structure. (location 3, Photo #5).

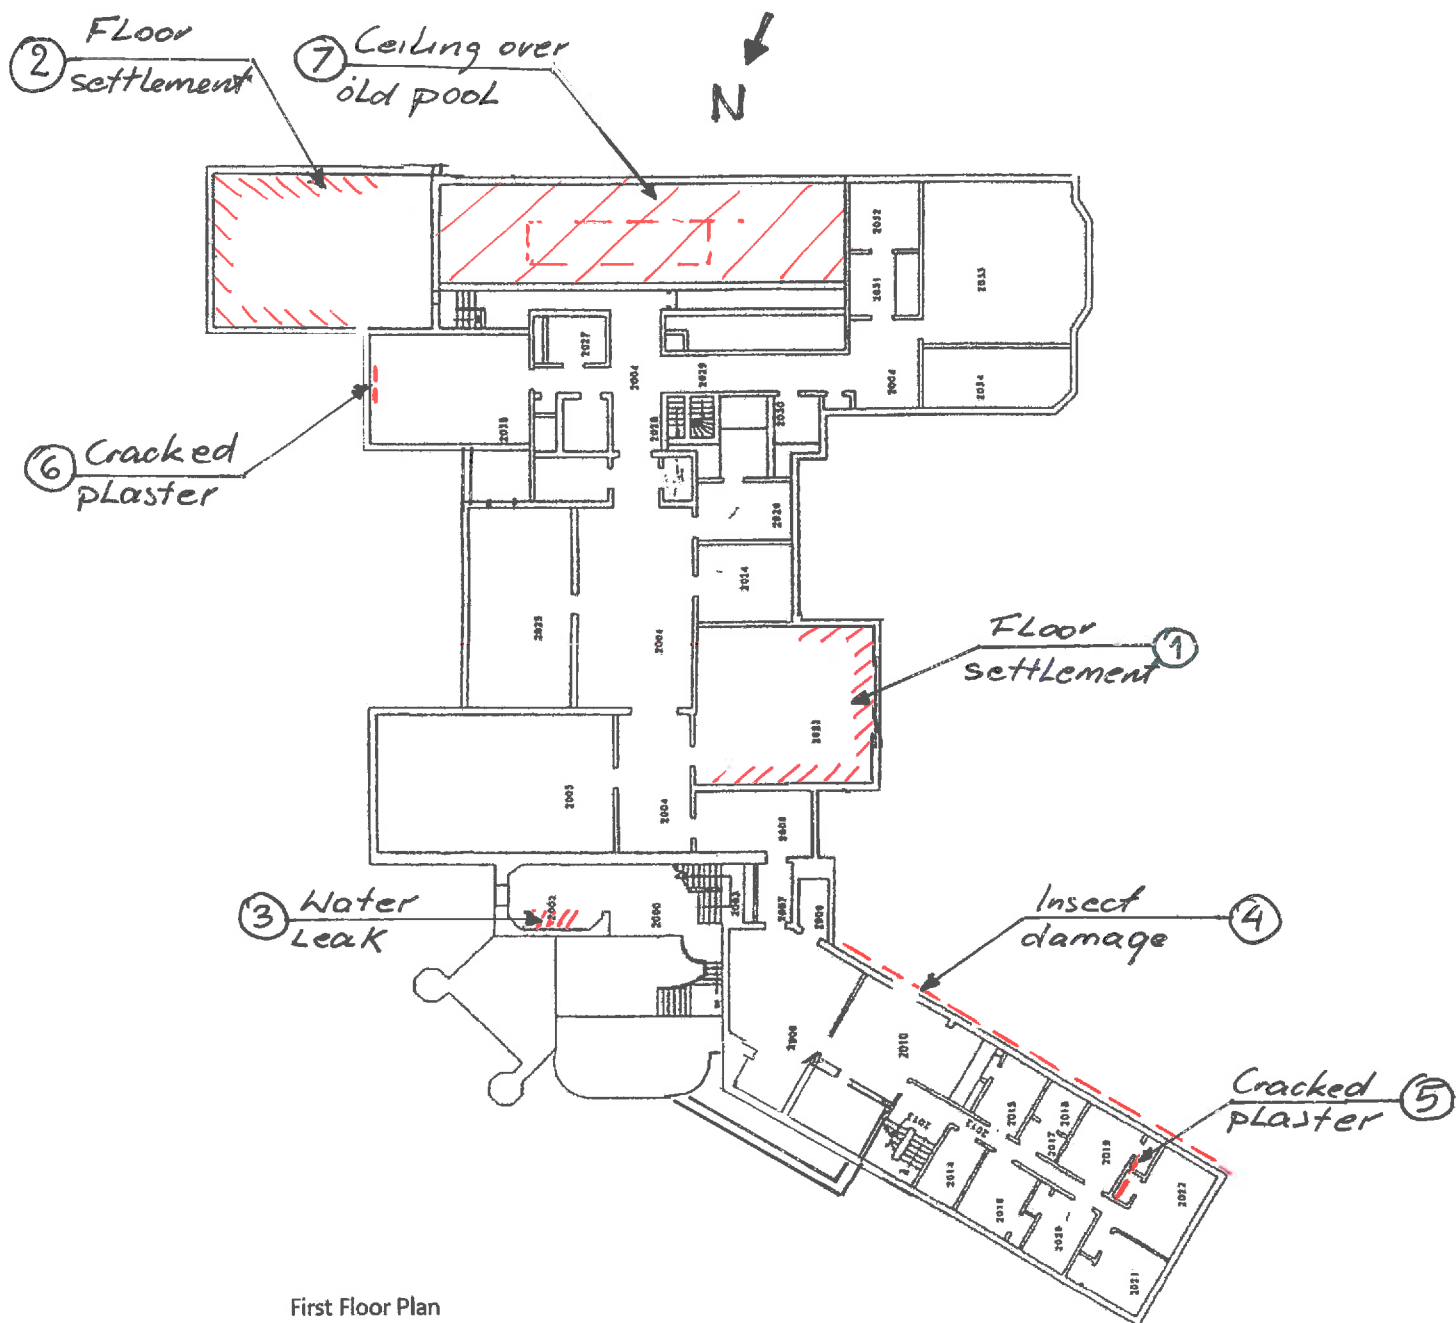
2. 1st Floor – area A, B and D - see plan Figure 5 for locations.

3. 1st floor – Area C see plan Figure 5 for locations
